Geotechnical Investigation across a Failed Hill Slope in Uttarakhand – A Case Study

ABSTRACT: A landslide triggered by a cloudburst in 2013 had blocked a major highway in Uttarakhand. The paper presents details of the geotechnical and geophysical investigations done to evaluate the failure and to develop remedial measures. Seismic refraction test has been effectively used to characterize the landslide and assess the extent of the loose disturbed zone. The probable causes of failure and remedial measures are discussed.

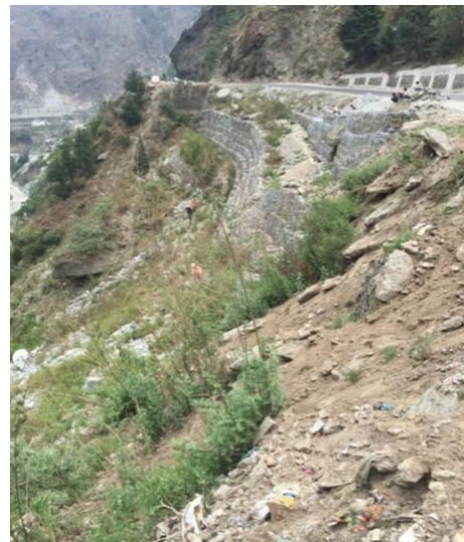
The rock mass in the area has unfavorable dip towards the valley side. In a 100-150 m stretch, the gabion wall on the down-hill side of the highway, showed extensive distress. The overburden of boulders and soil had slid down, probably due to buildup of water pressure behind the gabion wall during heavy rains. Drainage is usually the main culprit in most landslides; the same can be observed here. A photograph showing the site condition is presented on Fig. 1.

Fig. 1 View of Hill slope showing landslide and movement of soil and gabion wall

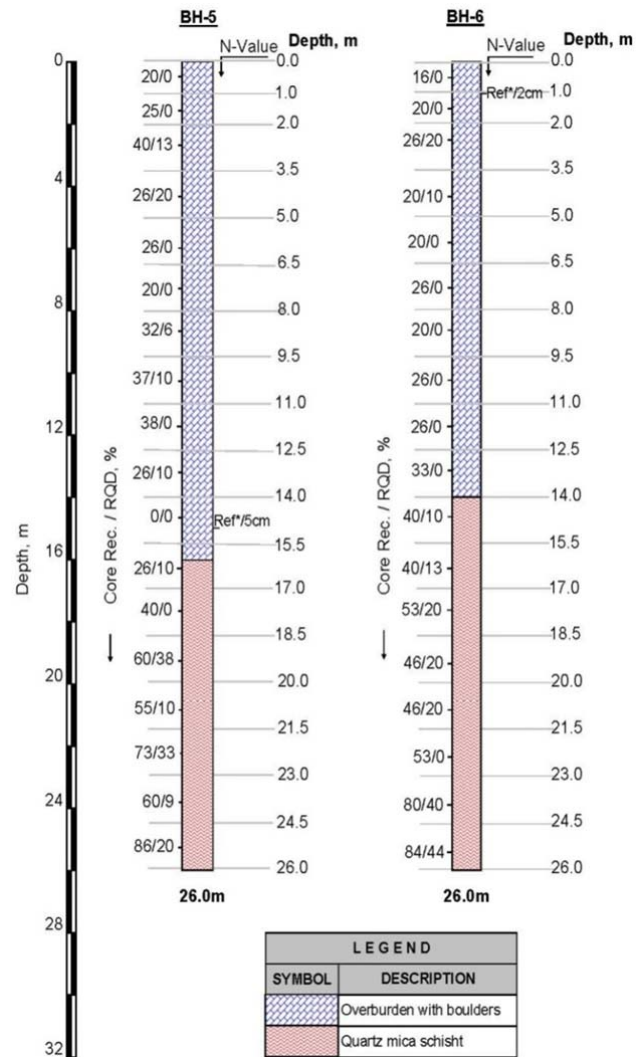
An overburden of boulders (colluvial deposit) is encountered to about 14-16 m depth underlain by quartz-mica-schist. The overburden is mostly landslide material. Typical borehole data is presented on Fig. 3.

Fig. 3 Summary of borehole profiles

It may be seen that the Layer 1 consisting of overburden soils with boulders is the slide-material in disturbed condition. The boreholes also indicate the presence of the overburden to 14-16 m depth. Fractured rock / hard rock met below the slide zone is the underlying stable zone.

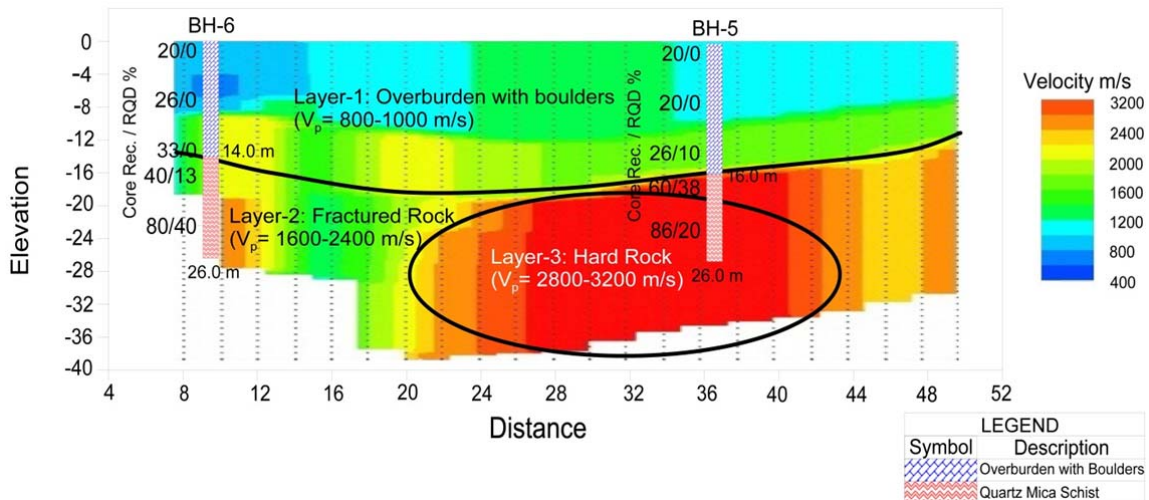
The survey was done along two lines. The geophysical litholog encountered along one line is illustrated on Fig. 4. It indicates a three-layered geological model. A slide-zone of overburden with boulders was clearly identified which can be correlated very well with the borehole data.

Fig. 4 Seismic sectional profile along the landslide

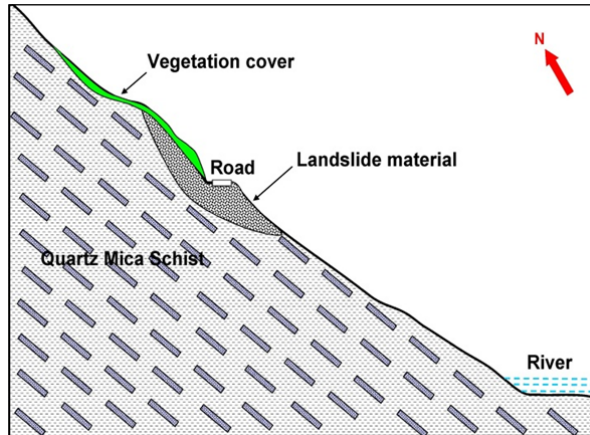
The site consists of rockmass units dipping unfavorably towards the valley side. A sketch showing the unfavorable dip and the failure zone is illustrated schematically in the geological section on Fig. 5.

Fig. 5 Schematic sketch illustrating the rock mass dip

The unfavorable dip of the rock combined with the build-up of pore water pressure behind the gabion wall and erosion of the river bank toe during heavy rains resulted in increased instability of the area.

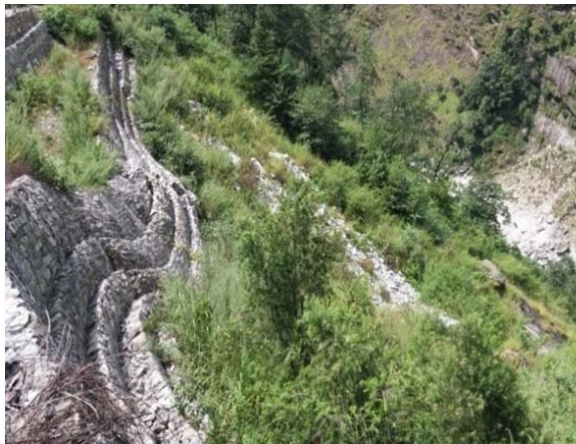
Improper drainage and movement of the rock mass along the weak planes are the major reasons of deflection of the gabion wall towards valley side. Erosion of the slope due to heavy rainfall resulted in movement of overburden soil along the valley slope.

Fig. 6 Displaced Gabion wall

As per the authors' assessment, the existing gabion wall on the valley side was inadequate to retain the loads.

A new reinforced soil wall has been proposed in place of existing gabion wall towards valley side. This reinforced wall is designed for the anticipated traffic, seismic forces and lateral earth pressure. The reinforced soil system is advantageous because of a better and uniform pressure distribution at the base of the wall.

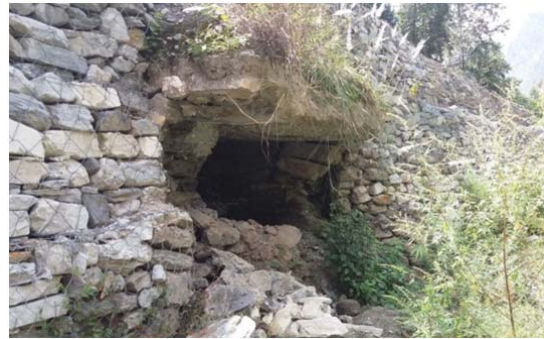
A culvert at the slide location (see Fig. 7) adjoining the gabion wall got choked, resulting in accumulation of water behind the wall. As a consequence, pore-water pressure built up behind the wall which probably is the triggering factor of failure. Erosion of the strata below the gabion wall resulted in differential settlement which led to tilting of wall.

Fig. 7 Damaged Culvert at the valley side

The drainage on the hill-side and valley-side was improved to channelize the water flow effectively and to minimize further buildup of pore-water pressure. This includes a series of culverts, catch-water drains and chute drains.

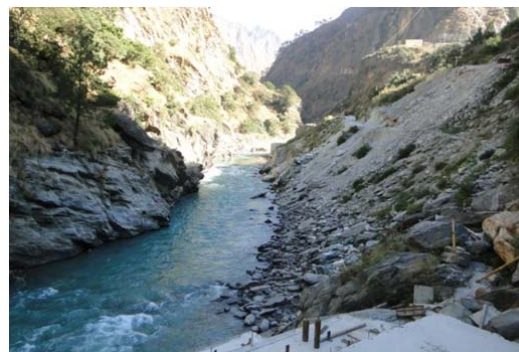
Distress was also observed at the toe adjacent to the river. The loose accumulated alluvium at the river bank toe gets further eroded in the rainy season (see Fig. 8).

Fig. 8 Eroded River Bank

A gabion wall connecting the gabion mattress has been proposed at the river toe. Gabion wall protects the exposed toe and reduces the erosion at that location while the gabion mattress protects the wall against scour as well as from flowing debris.
