Foundations for an Overhead Tank – Forensic Assessment

Ravi Sundaram & Sanjay Gupta
Cengrs Geotechnica Pvt. Ltd., Noida, Uttar Pradesh, India
J. T. Shahu & Bappatiya Manna
Department of Civil Engineering, Indian Institute of Technology, Delhi, India

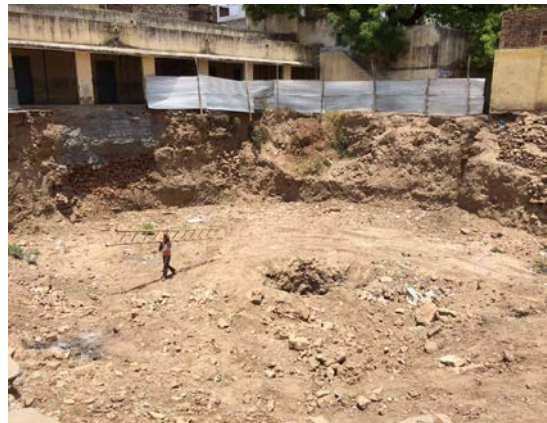
Excavation was done to 4 m depth and it was noticed that the stone filling is loose, heterogeneous and non-uniform. Some of the stones seem to be part of an old stone masonry construction probably part of the fort construction during ancient days. Figure 1 presents a photograph of the excavation.

On seeing the nature of the fill, the contractor and the owner were concerned that the strata at 4 m depth may not be suitable bearing material.

Figure 1. Excavation to 4 m depth showing loose heterogeneous boulders and stones in a soil matrix

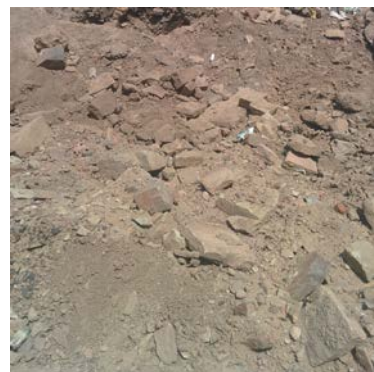
- The fill encountered at site is loose, heterogeneous and non-uniform. It consists of stones mixed with soil. Some of the stones seem to be part of an old stone masonry construction. It could probably be part of the nearby ancient fort (See Figure 2).

Figure 2. Loose soil and boulders at base of excavation

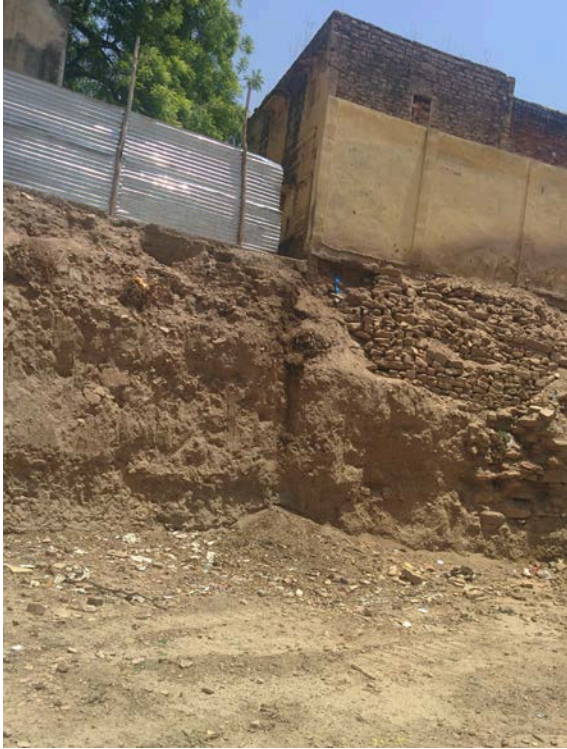
- Several very-loose pockets are observed in the fill.
- Due to the presence of several buildings in the surrounding areas, the excavation has been carried out very close to these buildings. Foundations of these facilities are at shallow depth.
- Some of the foundations are exposed. Figure 3 illustrates the steep vertical cut adjoining the existing building.

Figure 3. Steep excavated slope of the boulder fill adjacent to nearby existing building

Shotcreting the exposed excavated slope after placing a welded mesh over it could reduce the level of risk further.

However, for a safe and reliable excavation, contiguous piles or diaphragm walls may be an effective solution. But this could push up the cost of construction substantially and make the project financially unviable.

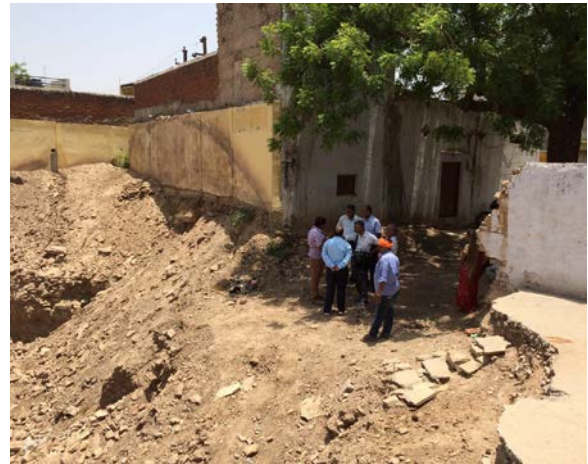
- In some areas, soil / fill material has been stacked up against the foundations of the existing buildings for lateral support to provide passive resistance. See Figure 4.

Figure 4. Boulder fill stacked up against wall of existing building

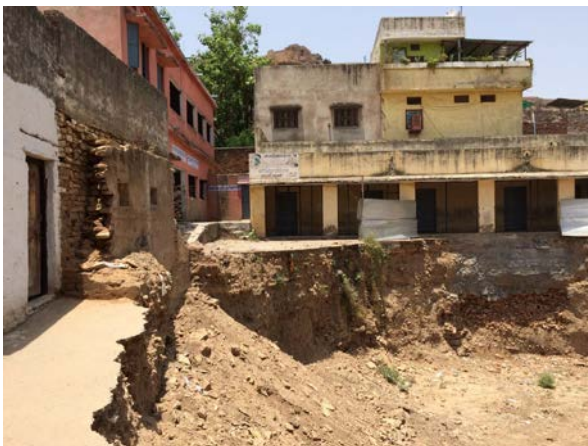
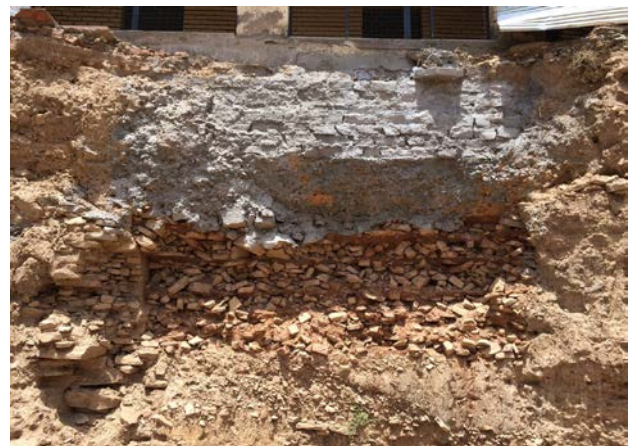
- Attempt had been made in one area to support the vertical cut by applying cement mortar on the exposed surface of fill.
- But the mortar was neither uniformly done nor was it of sufficient thickness as may be seen in Figure 5.
- Also, only part of the area has been stabilized when the contractor realized it shall not serve the desired purpose.

Figure 5. Attempt to stabilize excavation adjacent to nearby school building by applying cement mortar – it is evidently a poorly done job

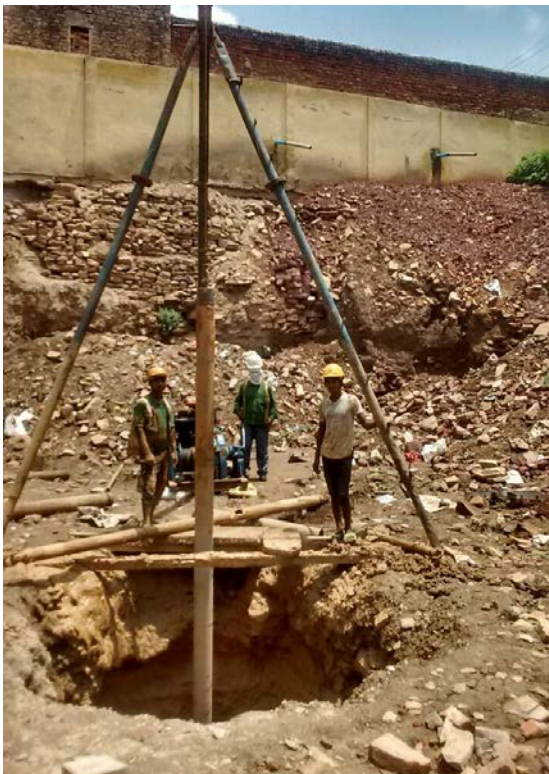
Figure 6. Borehole drilling in progress

A temporary work platform of wooden sleepers and bamboos was set up over the pit excavated for ease of boring activity (See Figure 6).

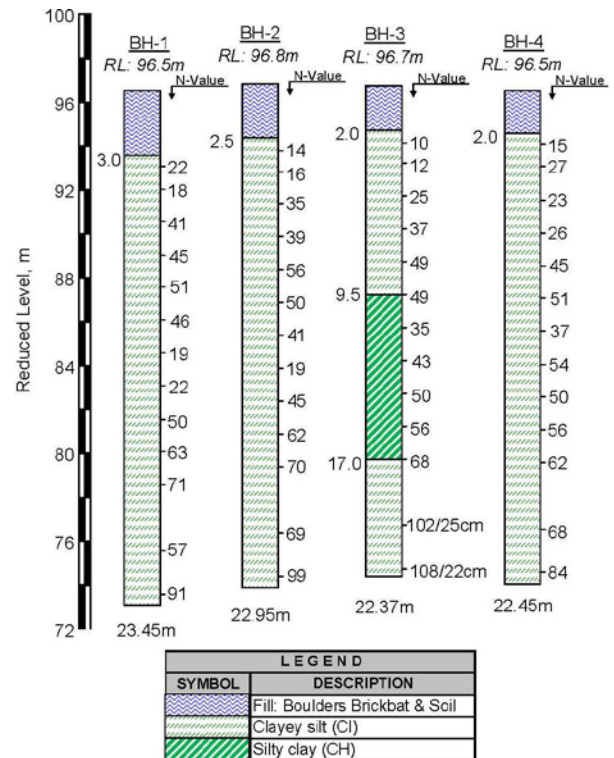
The investigation was done from the excavated level of 4 m below the road level which is at RL 100.5 m. The heterogeneous fill of gravel, boulders and building stones extends to 2-3 m depth below the excavated level (6-7 m depth below road level).

Figure 7. Summary of borehole profiles

The natural soil below the fill classify as clayey silt of medium plasticity to the maximum explored depth of 23.5 m below the excavated level. The field SPT values in the natural soil generally range from 10 to 15 to 5.0 m depth and gradually increase with depth.

Groundwater was not met to the maximum explored depth of 23 m below the excavated level.

Therefore, the authors advised the owner to place the raft foundation on the natural soils at 7 m depth below the road level. This shall entail removal of the boulder fill and construction of foundation on the natural soils below the fill.

Restricting the total settlement of the raft foundation to 50 mm, the safe net allowable bearing pressure works out as 225 kN/m² on the natural soils.
