Stabilizing a Highway in the Fragile Himalayan Terrain – Case Study of Gulabkoti Landslide

Minimol Korulla¹, Ravi Sundaram², Sorabh Gupta² and Meenu P. S¹

ABSTRACT

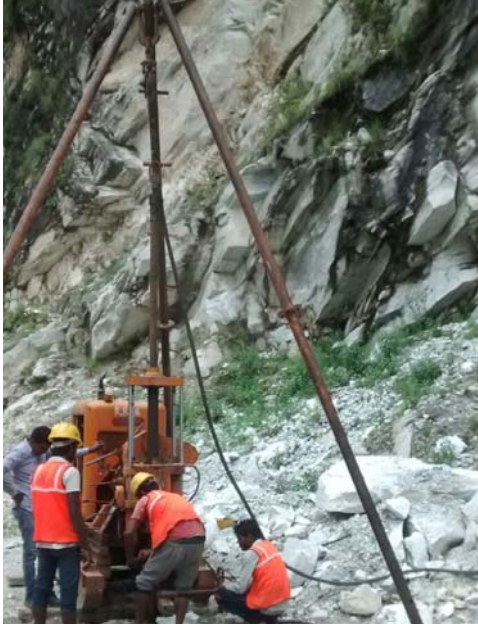
Fig. 2. Drilling in progress

Fig. 2 presents a photograph of the geotechnical investigation in progress. The steeply dipping rocks on the hill-side and the rock pieces that have fallen down as a result of the slide is depicted in Fig.2.

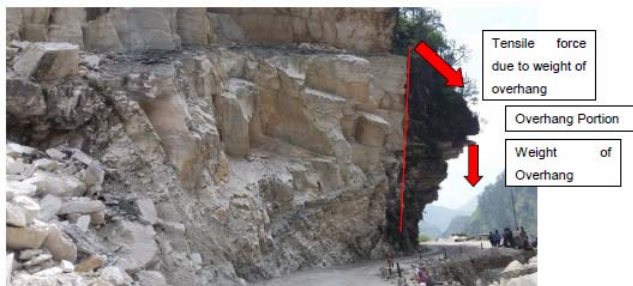
Fig. 7. Rock Overhang at Gulabkoti

The site comprises of heavily jointed rock mass with weak planes along the foliation. At places, tensile force was developed in the rock-mass overhangs due to weight of the overhang. The fractured rock mass is prone to collapse, particularly if water seeps through the joints. Fig. 7 shows the overhanging fractured rock-mass.

After cutting the hill side between Ch 464+400 and Ch 464+430, rock-fall was arrested with a system of secured drapery i.e with nails and high-resistance mesh.

The system was composed of anchors (steel bars), to stabilize the slope and a mesh which contains the debris or the rock blocks that might move between the anchors. The system, illustrated on Fig. 10 is passive, because both mesh and anchors start to develop resistance if one or more blocks start to move.

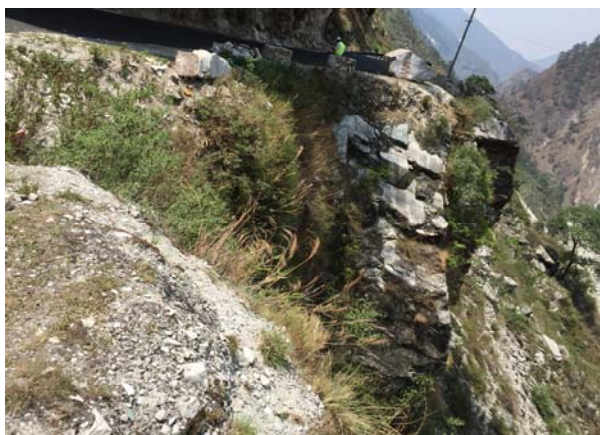
Fig. 8. Foliated rock & blocks of rock below road level

In addition, there are weak layers, comprising mica, along the foliation plane. The foliation is dipping towards the road (at shallow angle) and kinematically free rock blocks may slide over the weak mica planes towards the road side (refer Fig. 8).

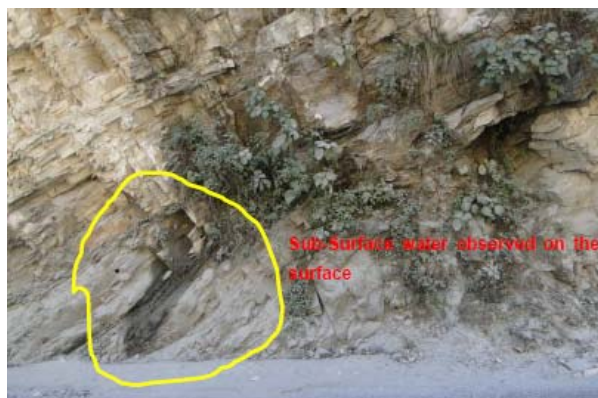
Fig. 9. Water seeping through jointed rock-mass

During rains, water percolates through the joints, generating pore-water pressure which makes the slope more susceptible to rock-fall. Fig. 9 illustrates water seepage through exposed rock-face.

To channelize the rain water properly and to address the issue of surface water, effective drainage measures were provided (see Fig. 10).

Shotcreting was done on the slope surface at drain location. Perforated PVC pipes were provided at

locations where sub-surface water is observed, along with provision of basin to absorb falling-water impact. The water from the basin was diverted to the road side drain and discharged to the existing culverts.
