# **FORENSIC EVALUATION OF DEFECTIVE BORED PILES OF AN INDUSTRIAL PLANT**

## **ABSTRACT**

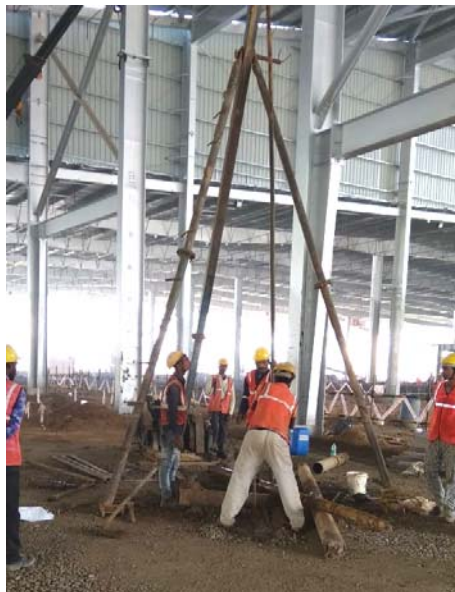
Fig. 2. Borehole in progress inside the factory structure

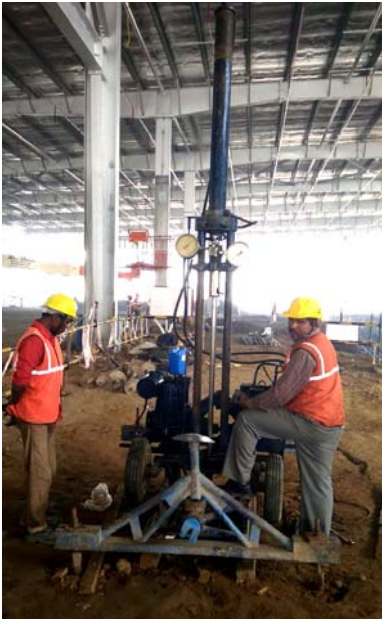
**Fig. 3. Static cone penetration test in progress**

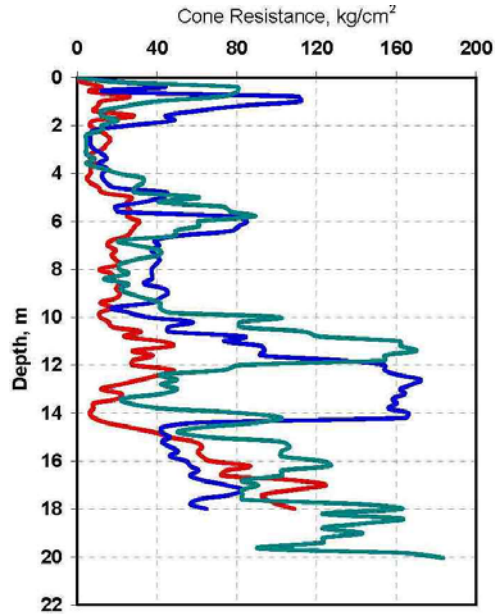
The cone tip resistance values also show a similar trend with low  $q_c$  values to 10-12 m depth. Figure 3 presents a photograph of the static cone penetration in progress. Plots of cone tip resistance versus depth are presented on Fig. 4.

**Fig. 4. Cone tip resistance versus depth**

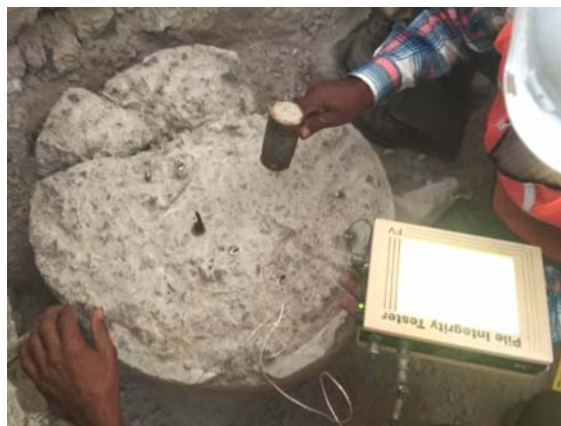
Low-strain pulse echo response test (pile integrity test, ASTM D 5882-00) using a handheld hammer was initially tried out by excavating a pit adjacent to the pile cap to expose the pile and impacting it from the side. But since the response was not good, the test was again carried out after dismantling the pile cap (Rausche et al, 1988). A small portion of the exposed pile top was leveled, and an accelerometer was placed on it. The hammer was impacted on the pile. A photograph of the test in progress is presented on Fig. 5.

**Fig. 5. Pile integrity test in progress**

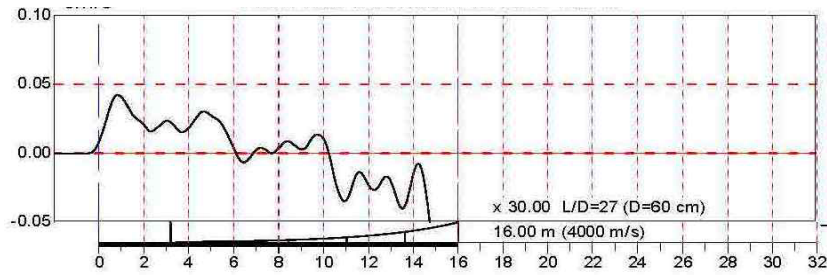
PIT results for Pile 238 are presented on Fig. 6 for pile impacted from the side and on Fig. 7 for pile impacted on the top. Similar data for Pile 239 are presented on Figs. 8 and 9 respectively.

**Fig. 6: Typical PIT record - Pile 238 impacted from side**

Pile No.	Test Condition	Number of Tests Attempted*	Observations and Interpretations
P238	Test done by excavating a test pit and striking the pile top from the side	6	Poor data quality. Test inconclusive.
	Test done from top of pile cap	4	Poor data quality. Test inconclusive.
	Test done from pile COL after dismantling the pile cap completely	17	Strong reflection at 3.5-3.6m depth, possibly due to bulging at this depth
P239	Test done by excavating a test pit and striking the pile top from the side	7	Data indicates either a defect at 6m depth below pile COL, or the wave could not penetrate below this level.
	Test done from top of pile cap	15	Weak toe reflection seen at the anticipated pile tip level. But uncertain and needs verification
	Test done from pile COL after dismantling the pile cap completely	19	Strong reflection at 3.5-3.6m depth, possibly due to bulging at this depth

It is noted that the variation in pile cross-section at 3-4m depths coincides with the presence of groundwater table. Since the pile boring was carried out using manual winch equipment without liners, it is likely that there might have been enlargement in the pile bore diameter at the groundwater table depth.

Due to significantly strong reflections from 3.5-3.6 m depths in Piles 238 and 239, it was not possible to determine the pile integrity below this depth. The authors suggested that the pile be exposed for physical inspection at this depth. However, the project owners refused to allow for the same, and chose to install additional piles at this location instead.

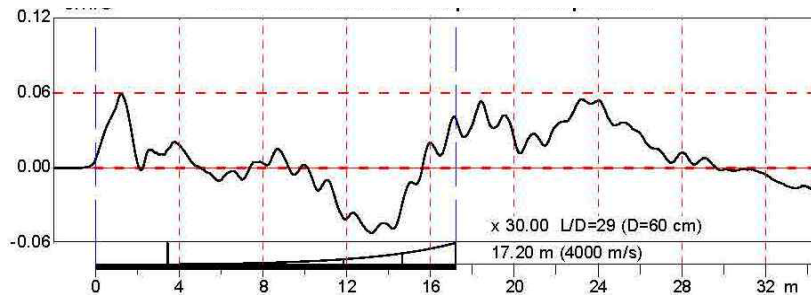
**Fig. 7: Typical PIT record - Pile 238 impacted from top**

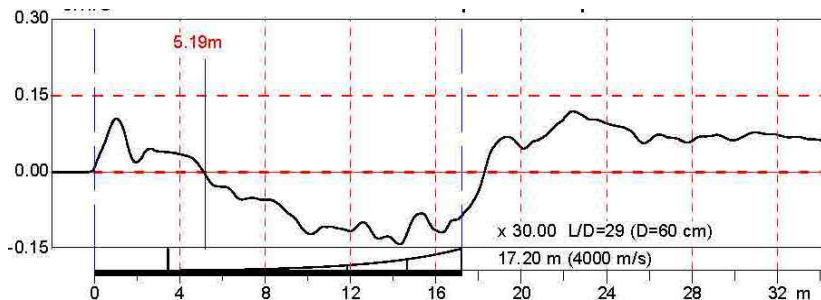
**Fig. 8: Typical PIT record - Pile 239 impacted from side**

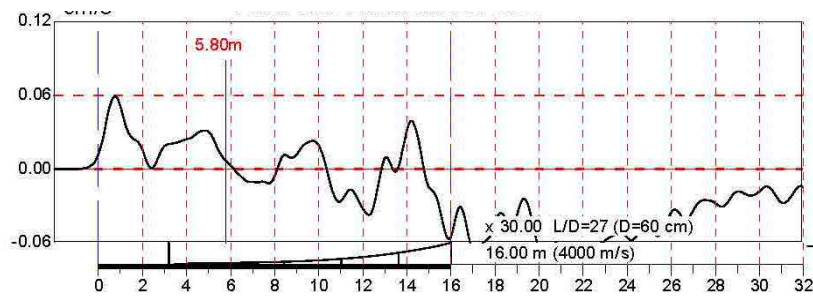
**Fig. 9: Typical PIT record - Pile 239 impacted from top**

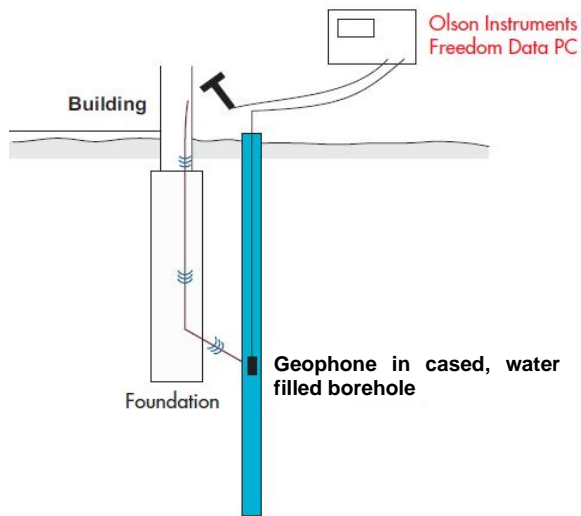
To assess the depth of the piles, parallel seismic test was performed in accordance with ASTM D4428/D4428M-00. The test can give reasonable assessment of depth of foundation and concrete quality (Sanjay Gupta et al 2015). The test involves impacting the exposed pile to generate seismic wave energy that travels down the pile and is sensed by a geophone receiver in a nearby borehole.

For this, a 150-mm diameter borehole was drilled about 1 m distance from the pile. The borehole was cased with 75 mm diameter PVC casing. The annular space between the borehole wall and the casing was backfilled using cement-bentonite grout.

A 5-kg hammer with a Teflon tip was used to impact the pile top. Triaxial geophones were lowered in the cased borehole to receive the compression and shear waves traveling down the foundation. Data acquisition to pick up the first arrivals (Primary wave) was done at every 1 m depth interval up to the final borehole depth of 20 m. A schematic of the test set-up is illustrated on Fig 10. Figure 11 is a photograph showing lowering of geophone into the hole.

**Fig. 10. Schematic of parallel seismic test**

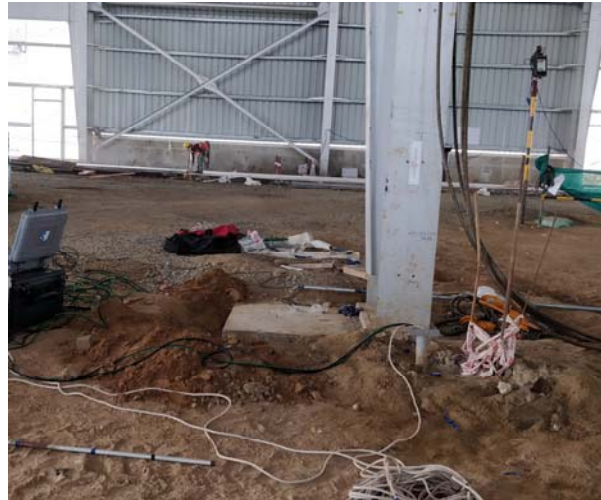
**Fig. 11. Borehole for parallel seismic test adjacent to pile cap**

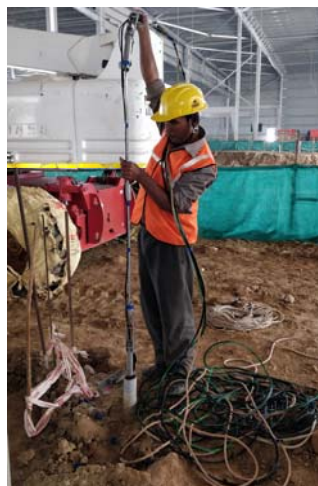
Figure 12 presents a photograph showing the lowering of geophone into the borehole.

**Fig. 12. Geophone being lowered into borehole**

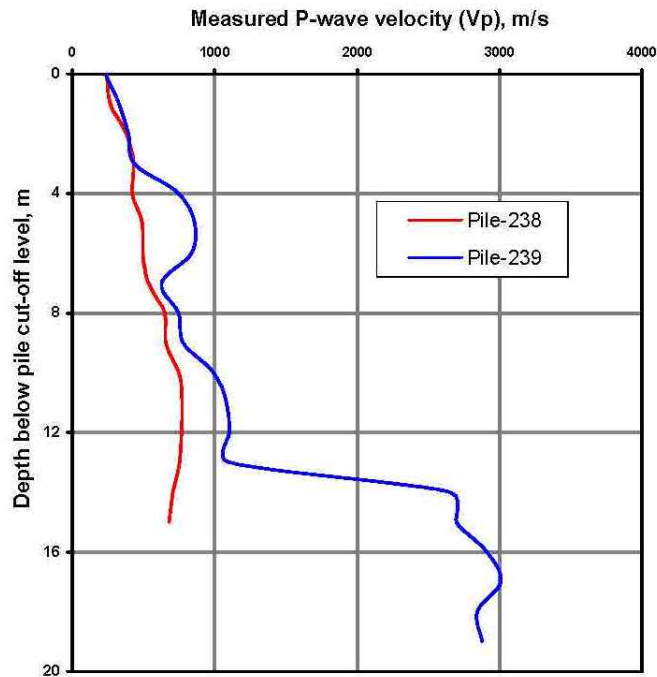
Figure 13 presents a plot of the measured wave velocity versus depth. The measured wave velocities are fairly low ( $\sim 1000$  m/s) in the top 12-15m depth, indicating that we are picking up tube waves- waves that travel down the water in the PS tube and not down the shaft. While there is no usable data obtained from P283, the sudden increase in measured wave velocity at P-239 at about 13.5m depth indicates a change of medium, i.e. earlier arrival of refracted waves travelling through the pile shaft, as compared to direct tube waves.

Fig. 13. Parallel Seismic test: P-wave velocity vs. depth

Pile No.	Possible Change in Impedance below Pile COL	Interpreted Pile Length below COL	Observations and Interpretations
238	~ 5 & 11 m	Unclear	Pile length could not be ascertained due to poor quality PS data (possibly due to soil cavitation in the test vicinity)
239	~ 3.5 m	Approx. 13.5 m	Some change in wave speed observed at 3.5m depth [matches PIT data]. Distinct change in wave velocity at 13.5 m depth [matches coring observations]

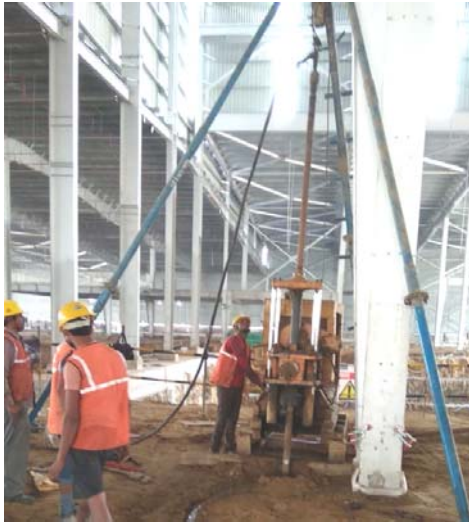
To confirm the pile quality and continuity, drilling was done through the piles using a hydraulic rotary core drilling rig. The drilling rig was set up at the pile-centre and leveled so as to drill vertically through the pile. A double tube core barrel with a 32-carat diamond impregnated core bit was used to maximize the core recovery and minimize mechanical fractures in the core. Fig. 14 presents a photo of the pile coring in progress.

Fig. 14. Coring through pile in progress

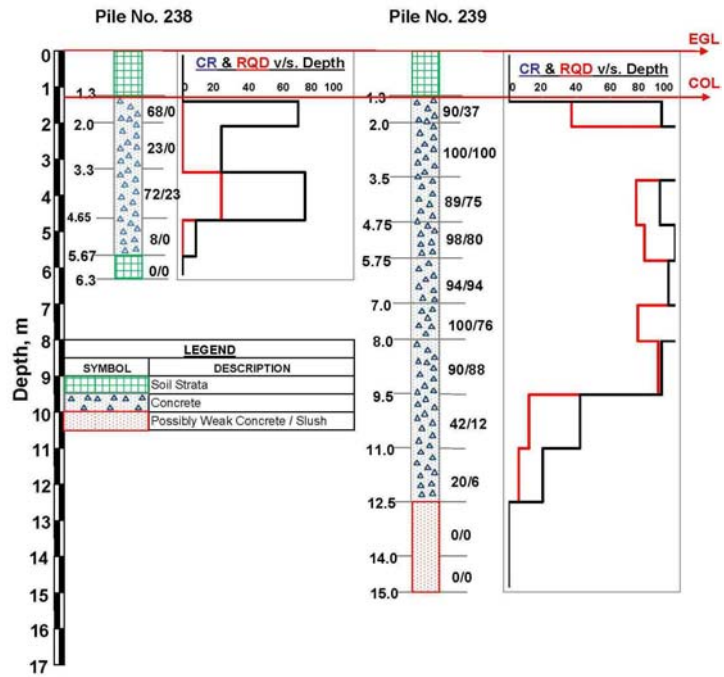
Fig. 15 is a pictorial summary of the drilling records and the core recoveries and RQD values for Piles 238 and 239. The observations and interpretations based on the pile coring are discussed in Table 3.

Fig. 15. Results of coring through pile

Pile No.	Maximum Explored Depth below COL	Depth at which soil was encountered	Observations and Interpretations
238*	6.3 m	5.67 m	<p>Bent longitudinal reinforcement pieces were found in last core run from 4.65-5.67 m depth. Soil was encountered in the pile bore at 5.67-6.3 m depth, and the coring was terminated in soil at 6.3 m depth.</p> <p>The pile may be bent / damaged at about 5-6m depth. Alternatively, there may be a major defect (soil inclusion, necking, short pile) at this depth.</p>
239*	15.5 m	12.5 m	<p>0-9.5 m depth: Fairly good core recovery indicating expected pile concrete and continuity.</p> <p>9.5-12.5 m depth: Core recovery % dropped significantly, which may be due to weak or discontinuous concrete.</p> <p>Below 12.5 m depth: Nil recovery &amp; RQD values.</p> <p>Color of the return water was gray, indicating that we were still drilling through concrete and not soil. Possible presence of weak concrete or slush, possibly intermixed with soil.</p> <p>Some reinforcement pieces (16 mm dia) were encountered in core run from 14 to 15m depth. Pile coring could not be extended below 15m depth due to reinforcement bars being encountered.</p>

Authors are of the opinion that the effective pile length may be only about 12.5m depth, below which weak concrete / pile bore muck is encountered, indicating poor bottom cleaning during pile installation.

**Pile 238:** Pile is bent or broken below 5.67 m depth, below which the testing results are uncertain due to variations in pile cross-section and possible cavitation in surrounding soil strata. The poor pile structural integrity, combined with the presence of loose soils in the pile vicinity, are a likely explanation for the pile settlement experienced at this location.

**Pile 239:** Effective pile length may be 12.5-13.5m, below which weak concrete / slush is encountered. Tests indicate poor bottom cleaning prior to pile concreting, which shall affect pile performance in-situ.
