Stabilizing a Highway in the Fragile Himalayan Terrain – Case Study of Gulabkoti Landslide

Minimol Korulla¹, Ravi Sundaram², Sorabh Gupta² and Meenu P. S¹

ABSTRACT

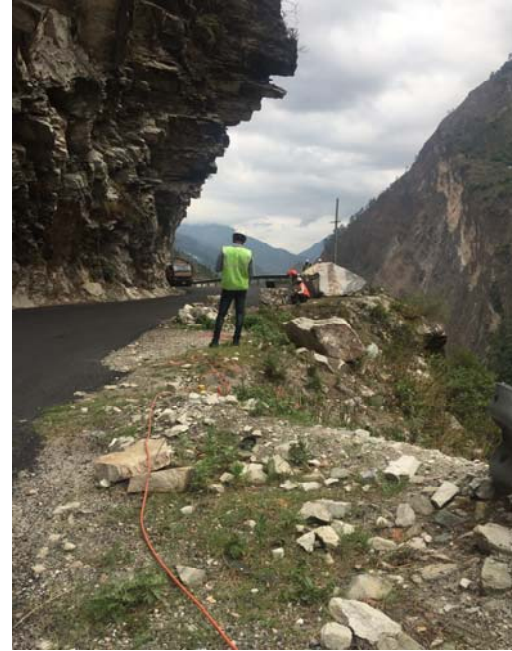
Fig. 3. Seismic Refraction test in progress

Fig. 3 is a photo of the seismic refraction test (SRT) in progress at site. A pictorial summary of the borelog illustrating the core recovery and RQD values is presented on Fig. 4. The geophysical litholog interpreted from one typical SRT is presented on Fig. 5.

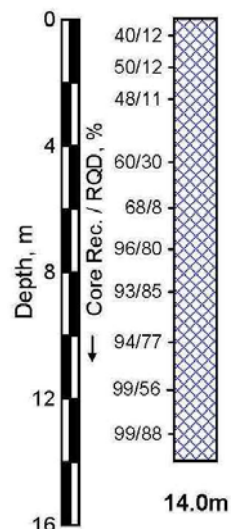
Fig. 4. Borelog

The rock at the borehole location classifies as quartzite. The quartzite zone is overlain at places by dolomitic limestone followed by siliceous marble.

The quartzites are highly sheared, highly jointed and fractured. Quartz veins and pockets containing mica, kyanite and tourmaline are abundant.
